WA105

Status and plans

ETH Zürich

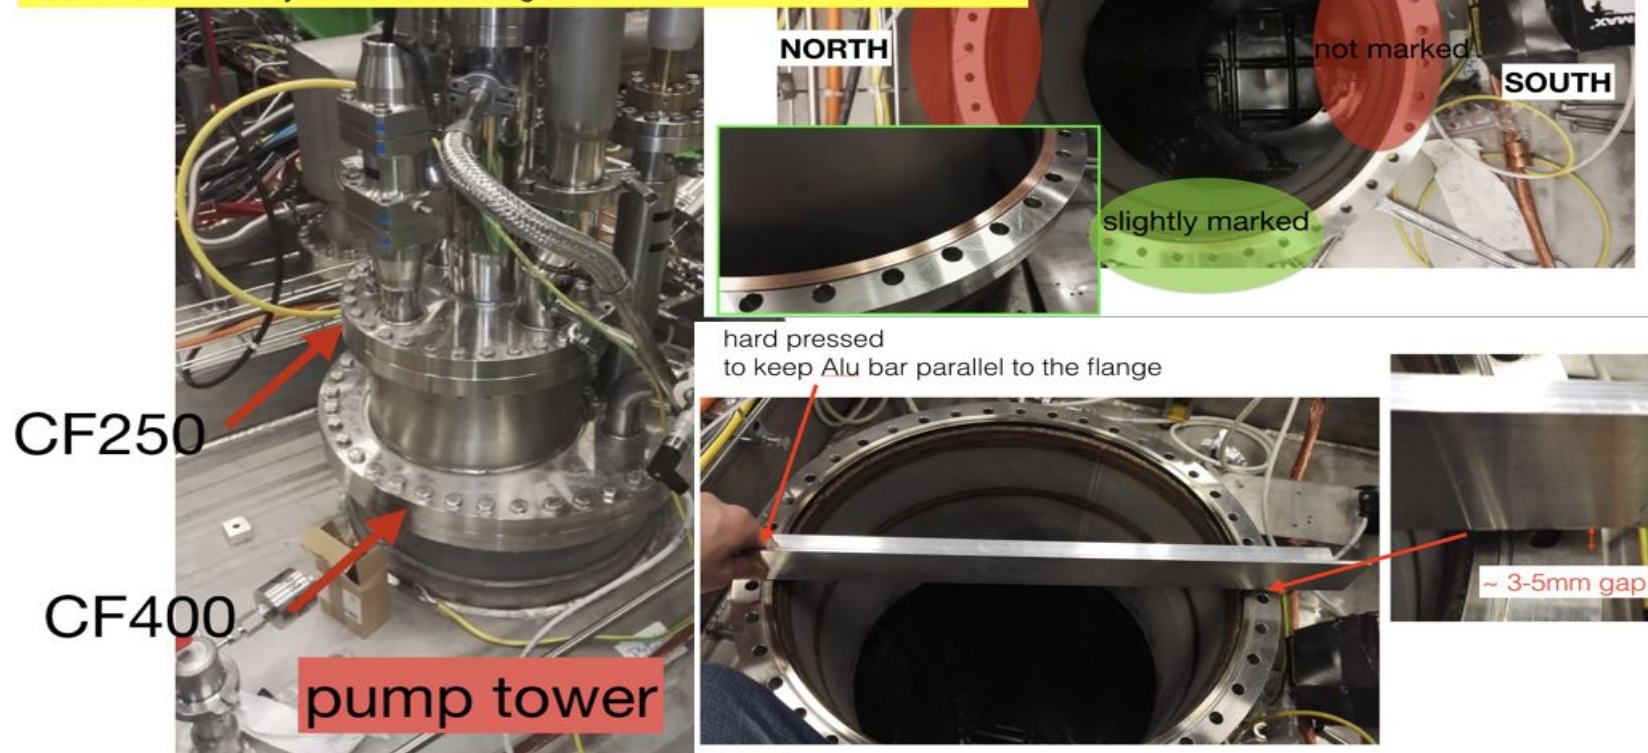
Problem reported on ELOG 66

- b. The gasket in the **CF-400 flange** was not properly fixed because the flange was deformed (not perfectly flat and round). This has been solved by carefully screwing and positioning the gasket.

Copper gasket slightly marked on two ends while there was no mark on the other two ends.

In addition, was difficult to keep the gasket in the correct position.

This might be due to either the deformation of the gasket itself or the CF400 flange at the top cap.

We pressed an aluminium bar tightly at one end of the flange to keep the bar parallel to the flange, on the other end of the flange there was clearly a gap ~ 3-5 mm between the bar and the flange.

This was found everywhere on the flange.

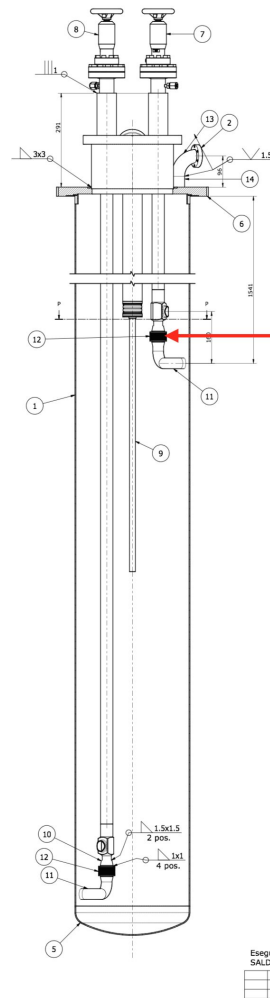
broken bellow

- **Major leak from pump tower to main volume:** there are two manual valves which connect the pump tower to the cryostat. We realized that even when both were closed, there was gas going from the pump tower to the cryostat. By inspecting with an endoscope, we found that **one of the bellows was broken**. It might have been damaged during transport. Last week, **we dismantled the pump tower and sent it to the CERN workshop for repairing and reinforcing. This is now fixed**: the pump tower has already been mounted on Wednesday (17/01/2016), whereas the pump has been reinstalled now. We are now able to re-start the purge in open loop!
